COUNTERWEIGHT SHEAVE

Inspection & Monitoring Program

Per Field Bulletin 23 January 2023

TKE FIELD BULLETIN 3 JANUARY 2023

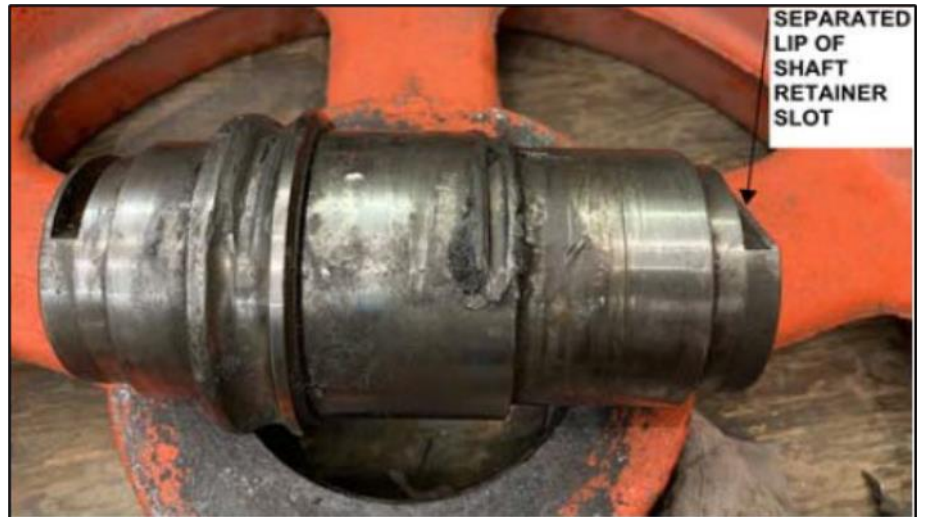
Most Bearings are sealed and lubricated for the life of the bearing. On good bearing the grease retainer shield must be intact, and no grease should be observed coming out of the bearing.

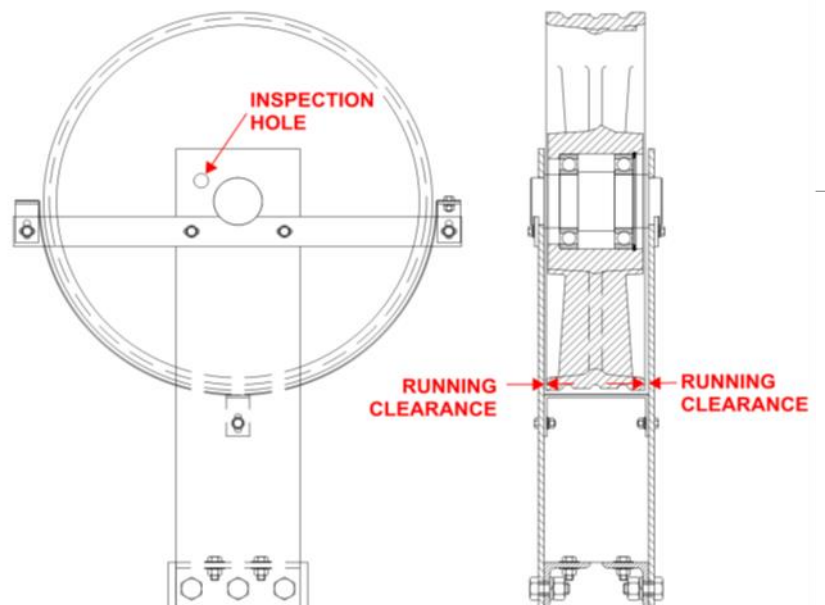
The running clearances on the front and back of the sheave should be the same dimension, different clearance may indicate bearing wear.

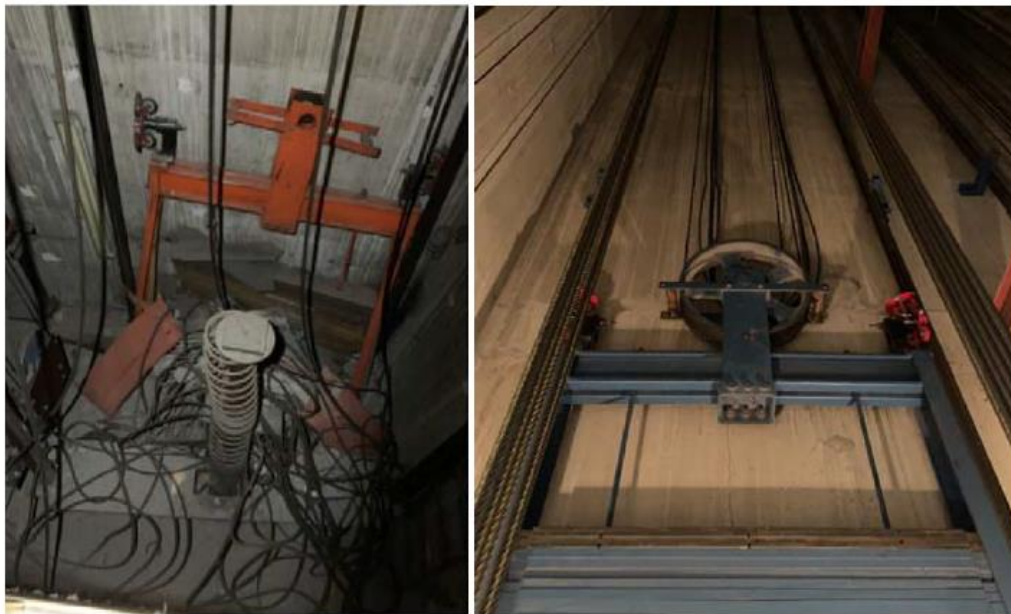
FIG 1 – Failure examples

Description: There is a possibility of a catastrophic failure when a counterweight sheave bearing fails and causes the sheave to seize and potentially cause the ropes to come off the sheave. Early detection of a possible failure is essential. In an extreme case the seized sheave will tilt and cause excessive force to be applied to the counterweight cheek plates, detaching the sheave and ropes from the CWT assembly which in turn would cause the counterweight and car to fall down the elevator shaft. There have been cases where the bearing failure has gone unnoticed, these scenarios have occurred on some Turnbull-Dover counterweights.

In both cases above the bearings failed on a unit manufactured by Turnbull – Dover, with 2:1 roping, where the sheave fixing arrangement failed which should have kept the pulley shaft in position even in case of bearing fracture.

TKE have also designed a retrofit kit to replace the sheave shaft and bearings. The retrofit kit also includes additional rope retainers to mimic the seismic requirements which prevent the hoist ropes from jumping off the sheave. This is now more relevant now that full speed, full load buffer and safety tests are mandatory which apply further stresses to the system.

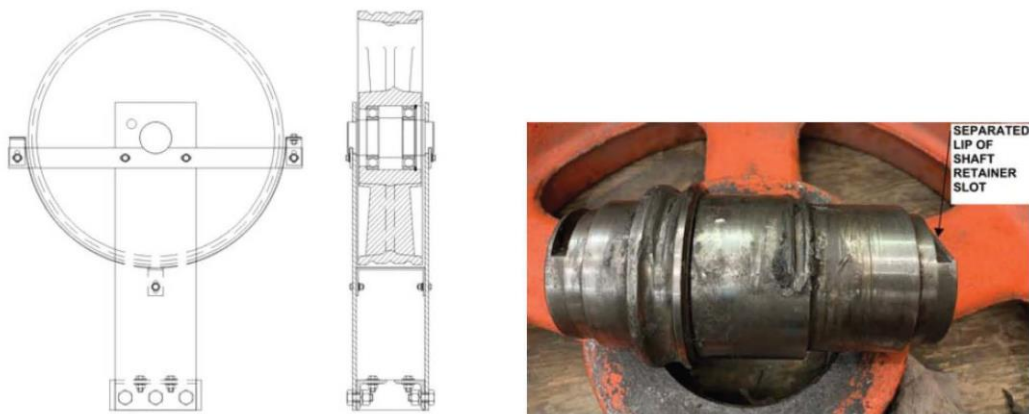
During normal elevator operation the counterweight (CWT) idler sheave separated off the CWT frame. CWT frame fell into the pit. CWT idler sheave fell on the car roof, penetrated through it and landed on cab floor. Car safeties applied stopping the car from a free fall.

The root cause of an incident is the failure of CWT idler sheave bearings. One of inner bearing rings got worn faster than the other allowing the outer ring with roller cage to relocate towards the center of the sheave shaft. Subsequent shaft wear allowed the sheave to skew out of plumb. Sheave started applying horizontal force on side retainer plates and on the lip of shaft retainer slot. The lip of shaft retainer slot snapped off and one side of the shaft dislodged from retainer plate making the sheave to separate off the CWT frame.

Method of preventing such accidents is periodic checks and replacement of sheave bearings. Note that bearings in this sheave design are sealed, lubricated for life, and cannot be lubricated. Bearing life span depends on use. Signs of bearing failure are vibration and noise.
