# TOP 10 GAS DEFECTS

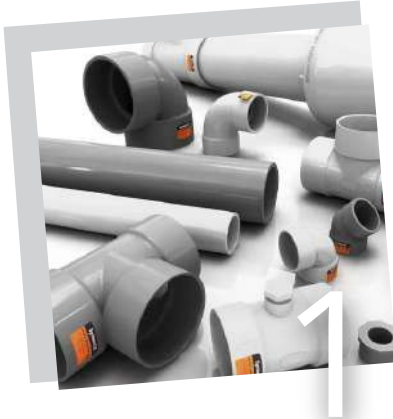
## INSTALLATION OF 636 PVC / CPVC

**349 DEFECTS WERE FOUND, CONSISTING OF:**

**128 Configuration of Venting**

- not terminated per manufacturers' instructions
- grading issues

**102 Assembly Issues**

- joints not glued
- leaking joints
- mis-matched material

**119 Not Adequately Supported**

- spacing exceeding 5 feet
- dips and sags

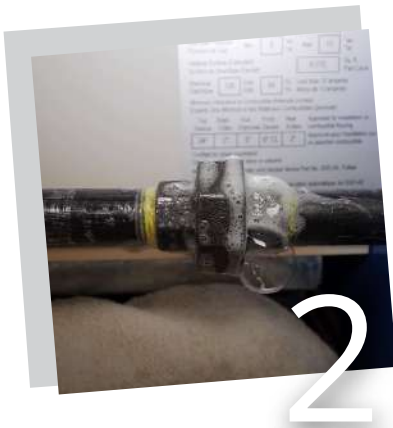
## GAS LEAKS

**327 GAS LEAKS WERE FOUND:**

- 152 black iron piping
- 79 black iron unions
- 56 CSST
- 25 flare joints
- 15 appliance connectors

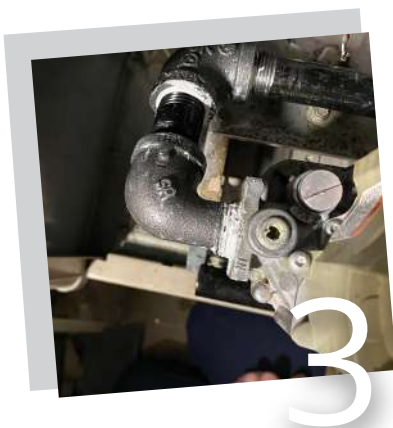
## SWING JOINTS

**272 DEFECTS WERE FOUND, CONSISTING OF:**

**136 Defects Related to Swing Joint Issues**

- piped incorrectly without two consecutive 90's on the same horizontal plane
- exceeds 45 degrees
- not installed

**107 Defects for Swing Joints for Appliances on Earth Supported Floors**

- 93 black iron swing joints
- 14 CSST requires offset

**29 Defects for Swing Joints on Underground Piping**

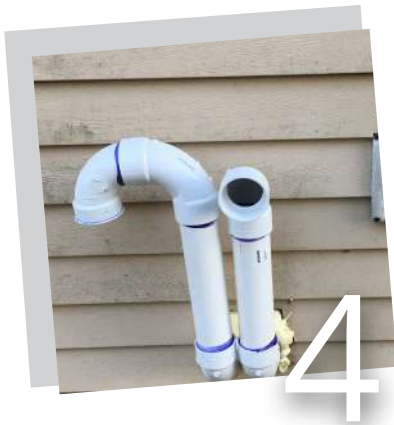
## SIDE WALL VENT TERMINATIONS

### 170 SIDE WALL VENT TERMINATION CLEARANCE DEFECTS WERE FOUND:

#### 106 B149.1 Non-Compliant

- vent to regulator
- vent to building opening
- vent to mechanical air intake

#### 64 SCOP Property Clearance

- 35 in the no go zone (less than 4ft to property line)
- 29 required directional device (between 4 and 8ft)

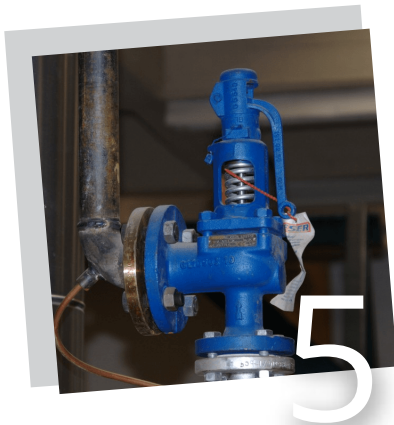
## RELIEF VALVES

### 119 DEFECTS WERE FOUND FOR RELIEF VALVE ISSUES:

#### 18 Miscellaneous

- 9 discharge reduced in size
- 2 boiler relief not installed upright
- 7 inoperable

#### 17 Not Installed

- 8 pool heaters
- 7 hydronic heating side
- 2 tankless water heaters

#### 73 Not Terminated Within 12 Inches of the Floor

#### 11 Others

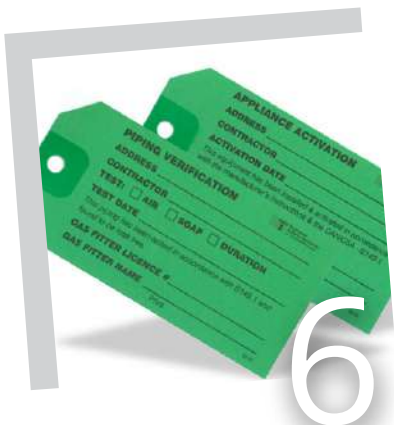
## ACTIVATION TAG NOT INSTALLED

### 117 DEFECTS WERE FOUND FOR NOT INSTALLING AN ACTIVATION TAG:

- primarily the result of not performing a start up

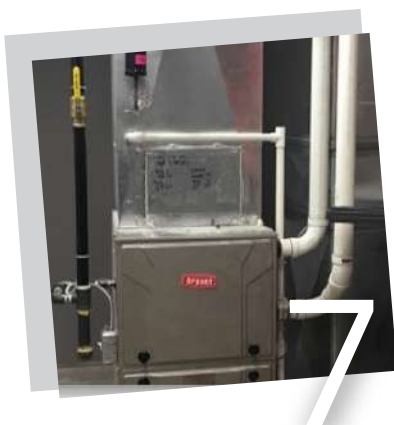
## PLENUM ACCESS

### 110 DEFECTS WERE FOUND FOR PLENUM ACCESS:

- too small for SCOP requirement
- too high above furnace
- cover installed but not cut-out
- access opening not provided

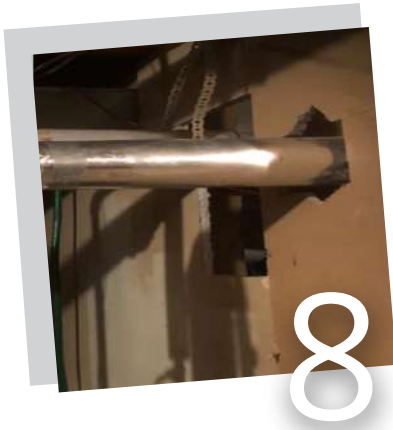
## CLEARANCE TO COMBUSTIBLES

**92 DEFECTS WERE FOUND FOR CLEARANCE TO COMBUSTIBLES:**

- 33 ranges or cook tops to cabinets
- 23 vent connectors
- 17 tube heaters
- 10 vent or chimney
- 9 others

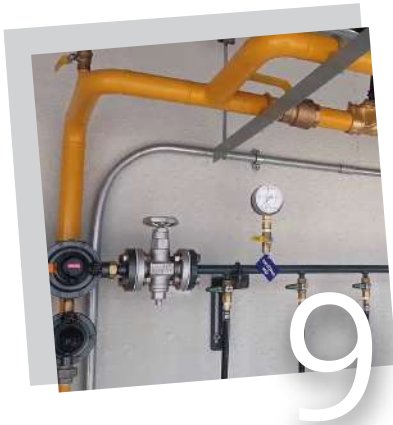
## SIZING OF GAS LINES

**81 DEFECTS WERE FOUND FOR UNDERSIZED GAS LINES:**

- 45 black iron
- 33 CSST
- 3 hose or connector

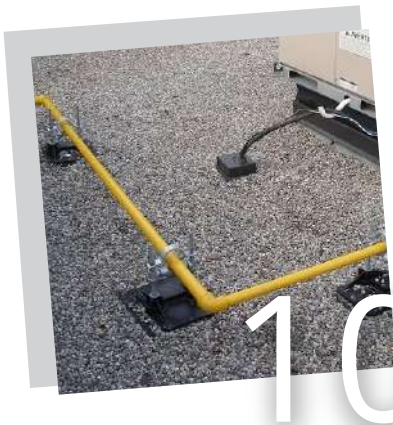
## SUPPORT OF GAS PIPING AND TUBING

**DEFECTS FOUND, OTHER THAN CSST:**

*67 Defects for Inadequate Support of Piping or Tubing Other Than CSST*

- primarily black iron
- copper tubing

*Defects Identified*

- maximum spacing exceeded
- non-metallic clips used
- roof top piping not supported at fittings
